**Flood Control Project Maintenance
Levee Inspections**

Fall 2015 Levee Maintenance Deficiency Summary Report

Solano County Public Works Mellin Levee

Levee Inspection Report By Mile - Fall 2015

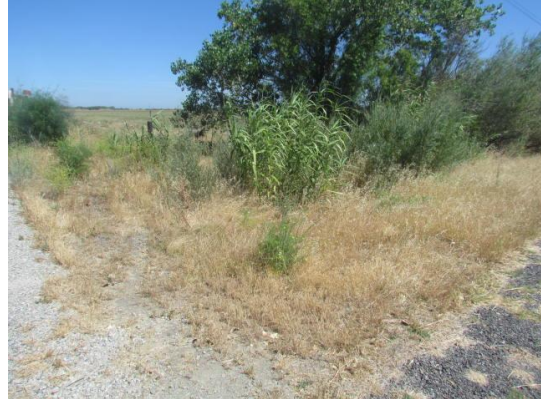
Photo 1 of 1 : FA_2015_NA0012_258_1_20150914_00001.jpg

LM Start	0.00	Rating **	M	Issue No.	1
LM End	0.00	Issue Type +	Ma	Location *	WS
Category	Earthen Levee			GPS Latitude/Longitude	
				Start	End
Item	Vegetation			38.174051 °	38.174051 °
				-121.674220 °	-121.674221 °
DWR ID	DWR_NA0012_01_s_2012_1				
Action/Comments					
Remove the wild growth other than native grasses from the levee slopes.					
Inspector Comments: Control Arundo on waterside slope at the entrance to the levee.

Looking west at arundo on waterside slope at entrance to unit.

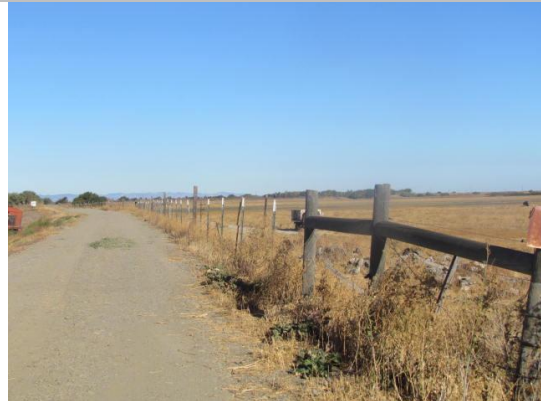
Photo 1 of 1 : FA_2015_NA0012_258_3_20150914_00002.jpg

LM Start	0.01	Rating **	M	Issue No.	3
LM End	0.49	Issue Type +	En	Location *	WS
Category	Earthen Levee			GPS Latitude/Longitude	
				Start	End
Item	Encroachments			38.174167 °	38.178960 °
				-121.674312 °	-121.680600 °
DWR ID	DWR_NA0012_01_s_2012_3				
Action/Comments					
Fence

Looking west at fence on waterside shoulder.

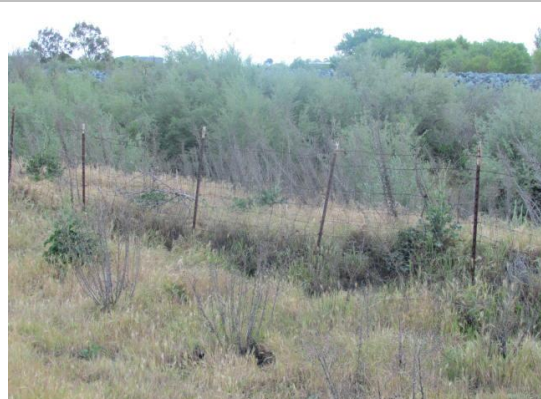
Photo 1 of 1 : FA_2015_NA0012_258_4_20150914_00003.jpg

LM Start	0.10	Rating **	M	Issue No.	4
LM End	0.28	Issue Type +	En	Location *	LS
Category	Earthen Levee			GPS Latitude/Longitude	
				Start	End
Item	Encroachments			38.175115 °	38.176805 °
				-121.675463 °	-121.677893 °
DWR ID	DWR_NA0012_01_s_2012_4				
Action/Comments					
Fence

Looking southeast at fence on landward slope.

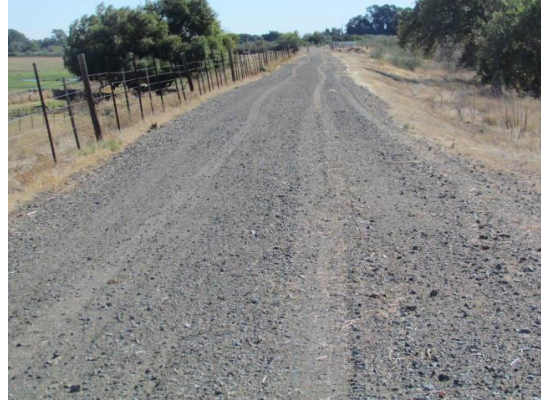
Photo 1 of 3 : FA_2015_NA0012_258_10_20151106_00009.jpg

LM Start	0.15	Rating **	A/W	Issue No.	10
LM End	0.59	Issue Type +	Ma	Location *	CR
Category	Earthen Levee			GPS Latitude/Longitude	
				Start	End
Item	Vegetation			38.175627 °	38.180044 °
				-121.676185 °	-121.681978 °
DWR ID	DWR_NA0012_01_s _ 2015_10				
Action/Comments					
Remove the wild growth other than native grasses from the levee slopes.					
Inspector Comments: Add appropriate gravel or road base.

Looking east at levee crown fall 2015.

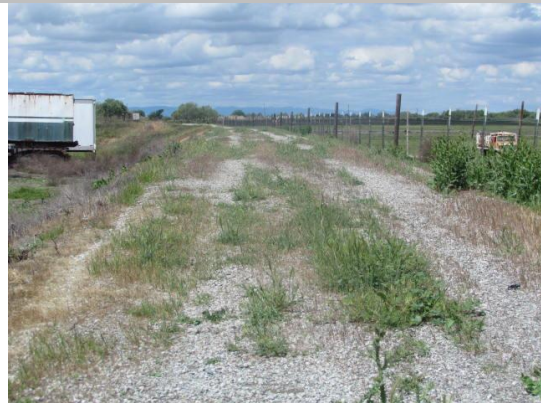
Photo 2 of 3 : FA_2015_NA0012_258_10_20150914_00006.jpg

Looking west at vegetation on levee crown at LM 0.00 to 0.10

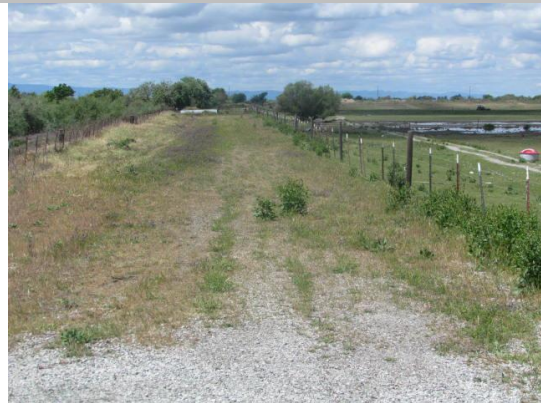
Photo 3 of 3 : FA_2015_NA0012_258_10_20150914_00007.jpg

Looking west at vegetation on levee crown at LM 0.28 to 0.59

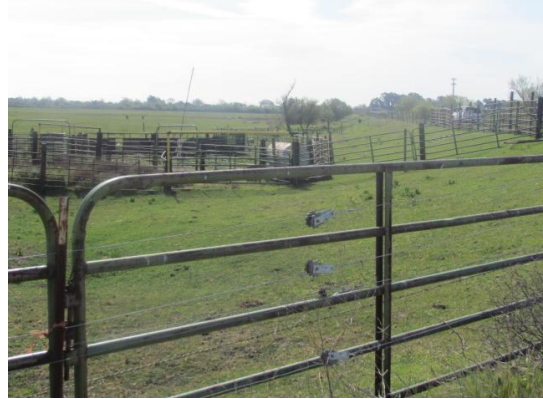
Photo 1 of 2 : FA_2015_NA0012_258_5_20150914_00004.jpg

LM Start	0.57	Rating **	M	Issue No.	5
LM End	0.59	Issue Type +	En	Location *	WS
Category	Earthen Levee			GPS Latitude/Longitude	
				Start	End
Item	Encroachments			38.179783 °	38.180027 °
				-121.681648 °	-121.681978 °
DWR ID	DWR_NA0012_01_s _ 2012_5				
Action/Comments					
Fence					
Inspector Comments: Animal corral.

Looking east at animal corral on waterside toe.

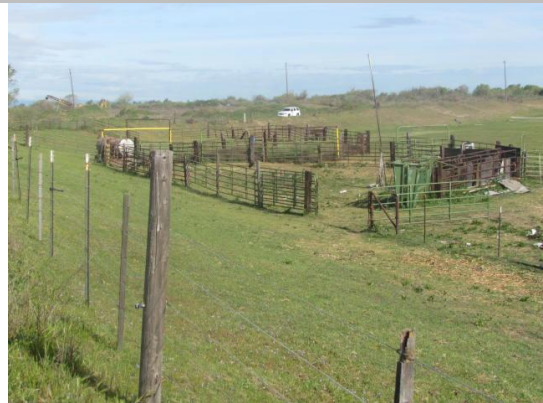
Photo 2 of 2 : FA_2015_NA0012_258_5_20150914_00005.jpg

Looking west at animal corral on waterside toe.

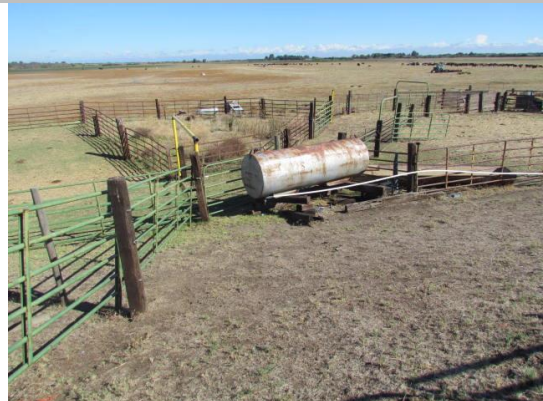
Photo 1 of 1 : FA_2015_NA0012_258_2_20151106_00010.jpg

LM Start	0.58	Rating **	M	Issue No.	2
LM End	0.58	Issue Type +	En	Location *	WS
Category	Earthen Levee			GPS Latitude/Longitude	
				Start	End
Item	Encroachments			38.179951 °	38.179951 °
				-121.681854 °	-121.681854 °
DWR ID	DWR_NA0012_01_f _ 2015_2				
Action/Comments					
Tank Inspector Comments: Water tank for watering cattle stored at waterward toe.

Looking north at water tank stored at waterward toe.

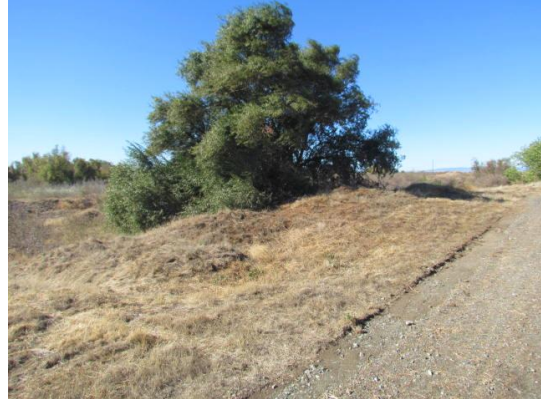
Photo 1 of 2 : FA_2015_NA0012_258_12_20151106_00011.jpg

LM Start	0.58	Rating **	U	Issue No.	12
LM End	0.58	Issue Type +	Ma	Location *	LS
Category	Earthen Levee			GPS Latitude/Longitude	
				Start	End
Item	Trim / Thin Trees			38.179966 °	38.179966 °
				-121.681872 °	-121.681872 °
DWR ID	DWR_NA0012_01_s _ 2015_12				
Action/Comments					
Trim trees to at least five feet above ground level.

Looking at untrimmed tree on landward slope fall 2015.

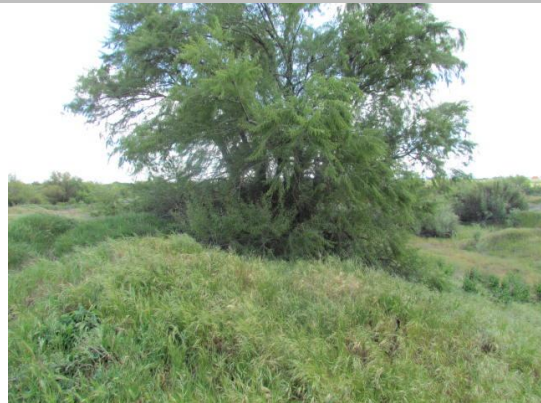
Photo 2 of 2 : FA_2015_NA0012_258_12_20150914_00008.jpg

Looking east at untrimmed tree on landward slope spring 2015
